Incident Waves, Historic Hurricane History and North Topsail Beach Shoreline Erosion Rates

William J. Cleary

10 January 2015

Characteristics of Incident Waves, Historic Hurricane History and North Topsail Beach Oceanfront Shoreline Erosion Rates

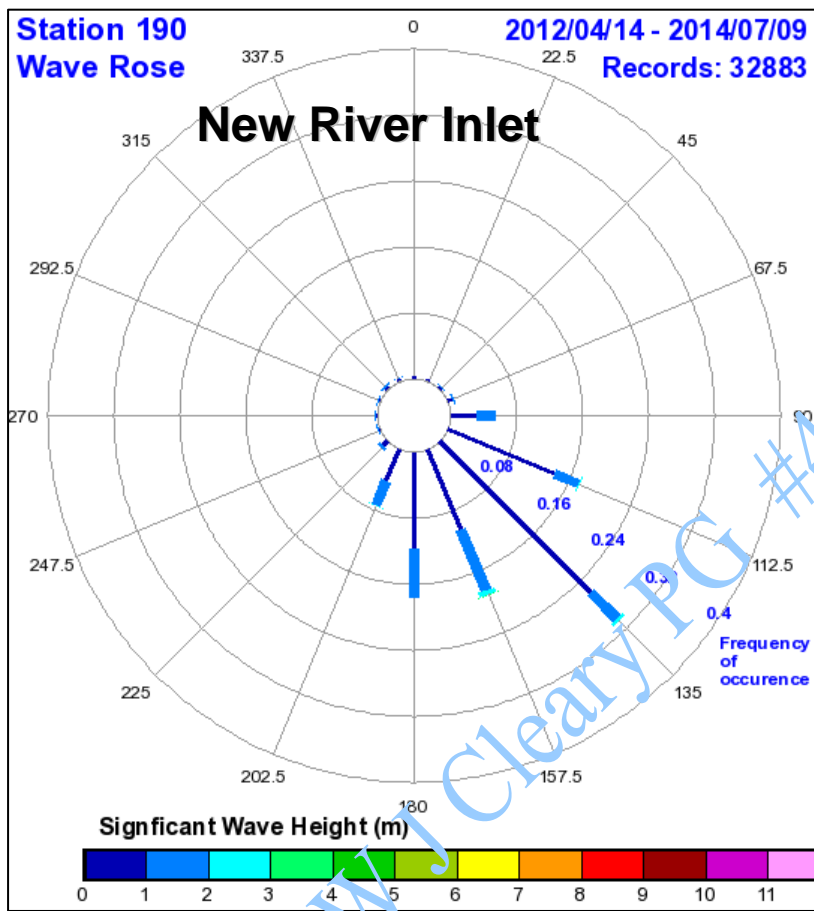
Figure 2. Rose diagrams depicting the significant wave heights recorded at Station # 190 (New River Inlet) and Station # 150 (Masonboro Inlet). The length of a petal portion corresponds to the frequency of occurrence. The significant wave height categories (m) are color coded. Modified after CDIP (Integrative Oceanography Division).

Wave height is used as a proxy or as an indicator of wave energy which is important because it drives the coastal (longshore) transport system. As wave heights increase the wave energy increases as the square of the wave height and hence the ability to erode and transport beach material also increases. Therefore, slight changes in wave height are important in both the long- and short-term. A comparison of the significant wave height (H_s , the average height of the one-third highest waves) from offshore North Topsail Beach and Wrightsville Beach, located in nearby New Hanover County, shows that the H_s data are similar, and in fact the H_s is slightly lower for North Topsail Beach (Figs. 2

and 3). Figure 2 also shows that the direction of wave approach is slightly different for North Topsail Beach but within the ESE –SE approach direction.

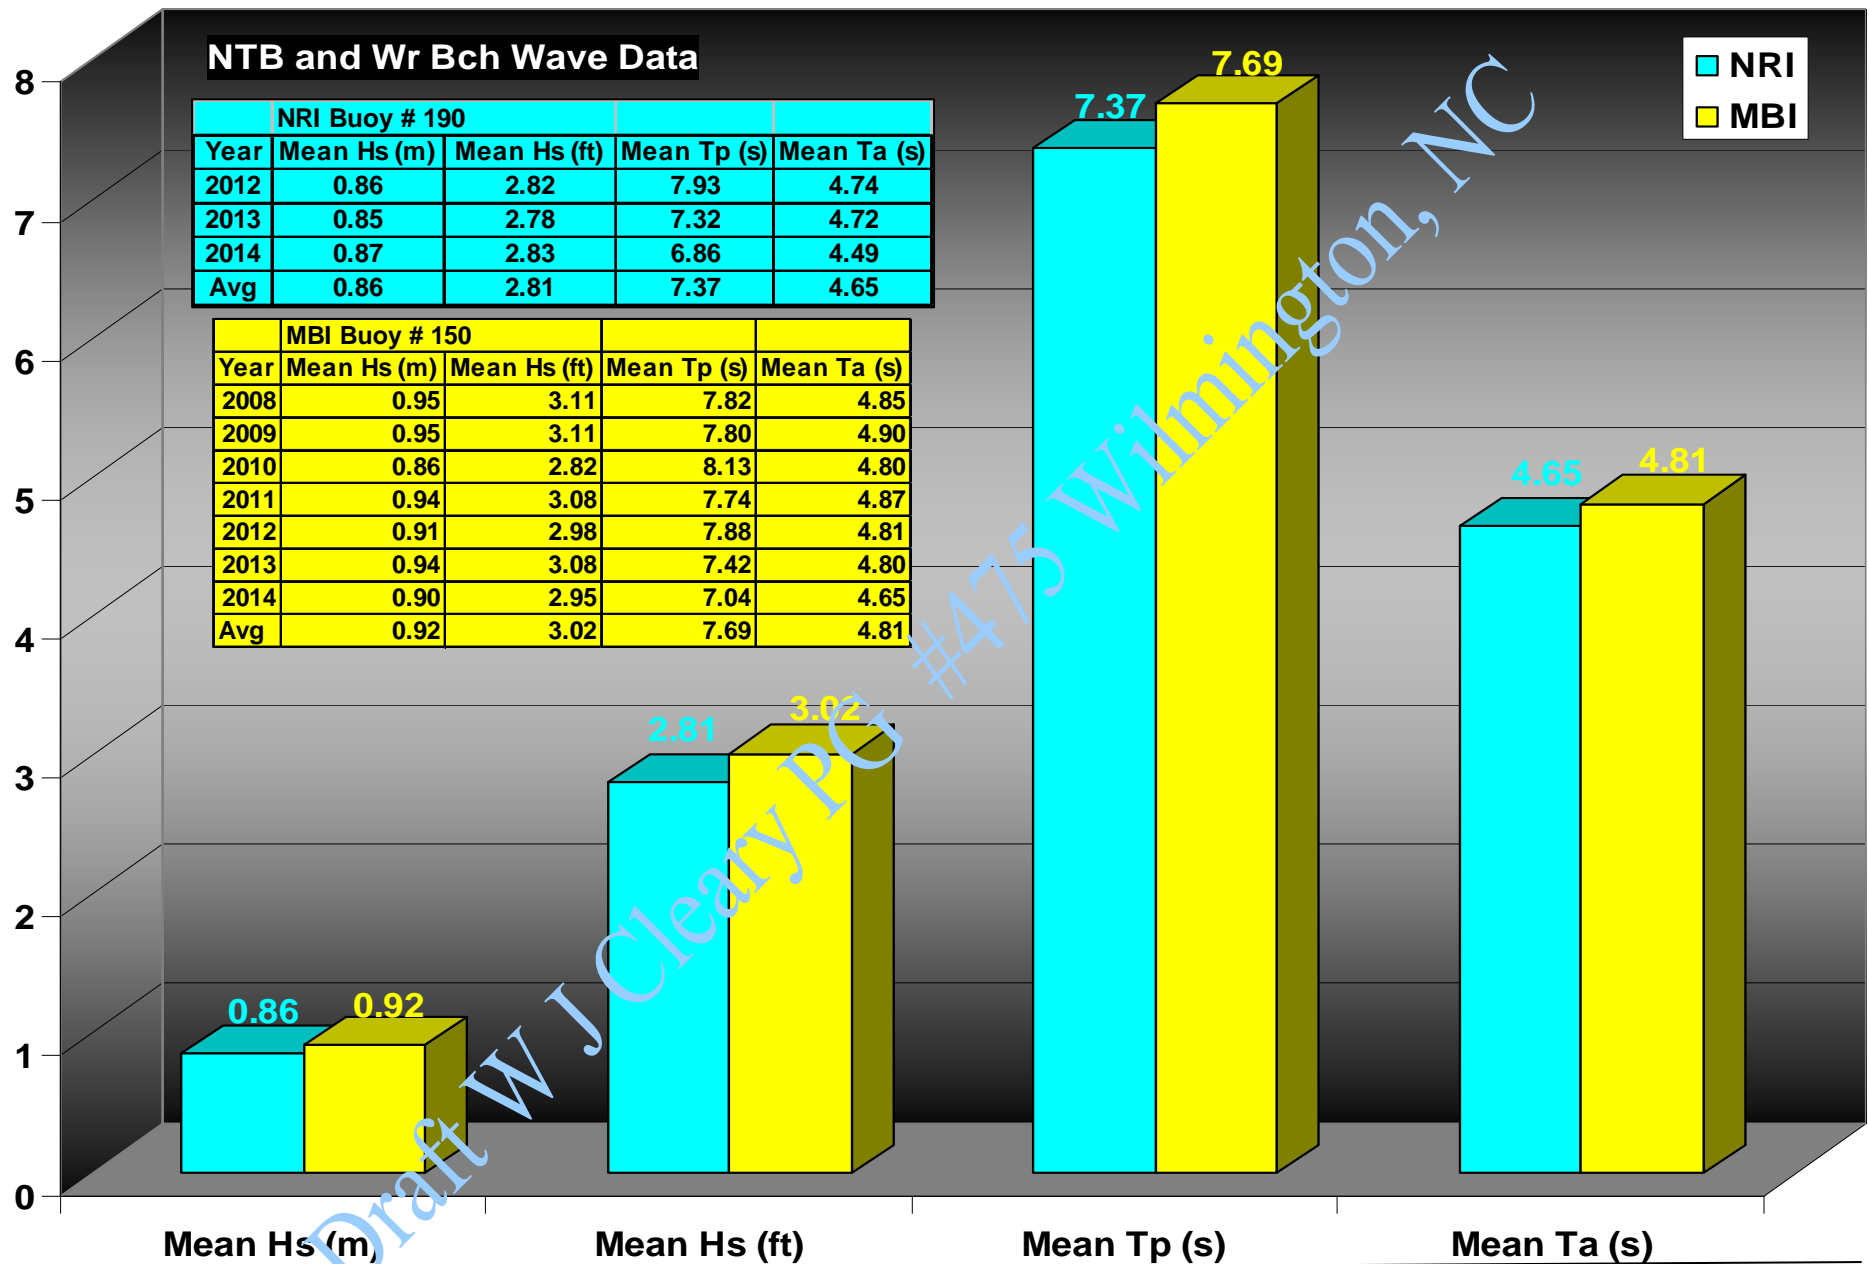
Figure 3. Bar Graph of depicting a comparison of wave characteristics for North Topsail Beach and Wrightsville Beach. Data were derived from offshore Buoy # 190 (New River Inlet) and Buoy # 150 (Masonboro Inlet). Modified after CDIP (Integrative Oceanography Division).

Figure 4 depicts Period Rose diagrams for the above offshore areas. The data show that slightly longer period waves, and hence slightly more energetic waves approach Wrightsville Beach than North Topsail Beach (Figs. 2 and 3). Although the differences are small the data pertaining to the wave characteristics do not support the contention of Pilkey and Neal (2009). Furthermore, the significant difference in the shoreline orientation of North Topsail Beach (N61°E) and nearby Wrightsville Beach (N32°E) in New Hanover County, indicate that due to the combined effect of the slightly higher H_s and the shoreline orientation, erosion and sand transport would be greater for Wrightsville Beach. From a regional perspective, North Topsail Beach is not characterized by persistent high wave energy (Fig. 4). In a relative sense, the wave energy along the shelf sector offshore Onslow County and New Hanover County is slightly greater than the wave energy offshore the Brunswick County barriers due the influence of the Cape Fear Foreland. However, by comparison to the areas north of Cape Hatteras, it is significantly less than that of the shelf sector offshore Dare County, where the storm-dominated barriers are subjected to persistent high wave energy (Fig. 5).

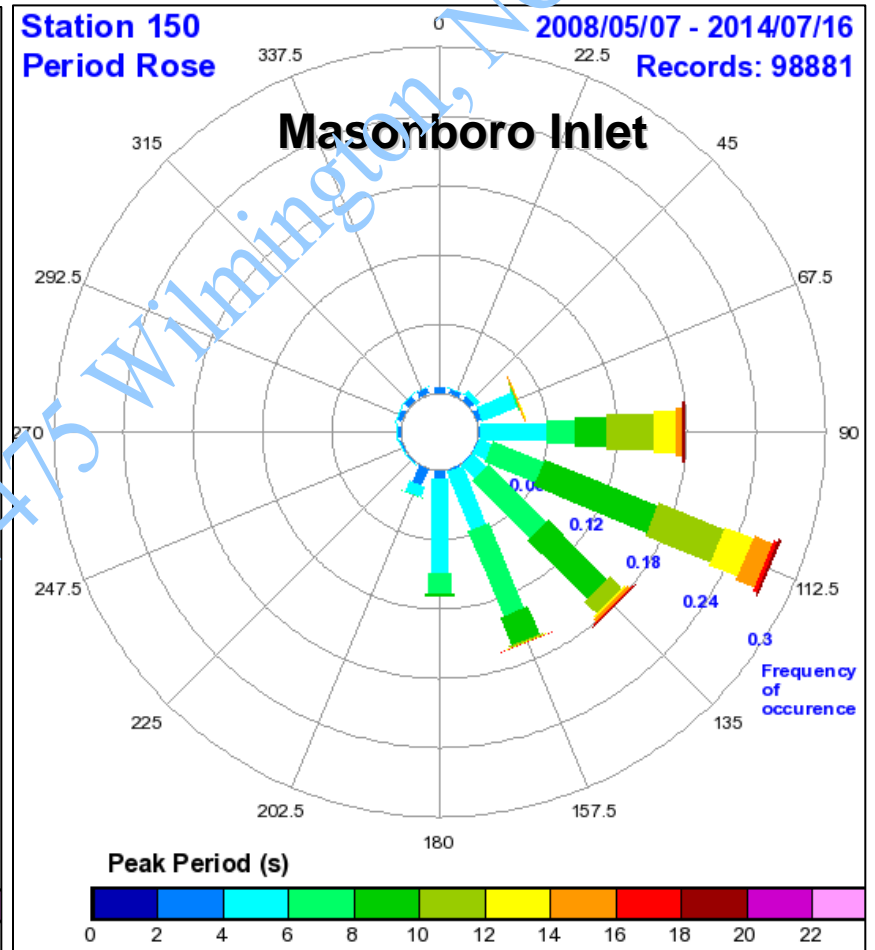
Figure 4. Rose diagrams depicting the peak periods recorded at Station # 190 (New River Inlet) and Station # 150 (Masonboro Inlet). The length of a petal portion corresponds to the frequency of occurrence. The peak period categories (secs) are color coded. Modified after CDIP (Integrative Oceanography Division).

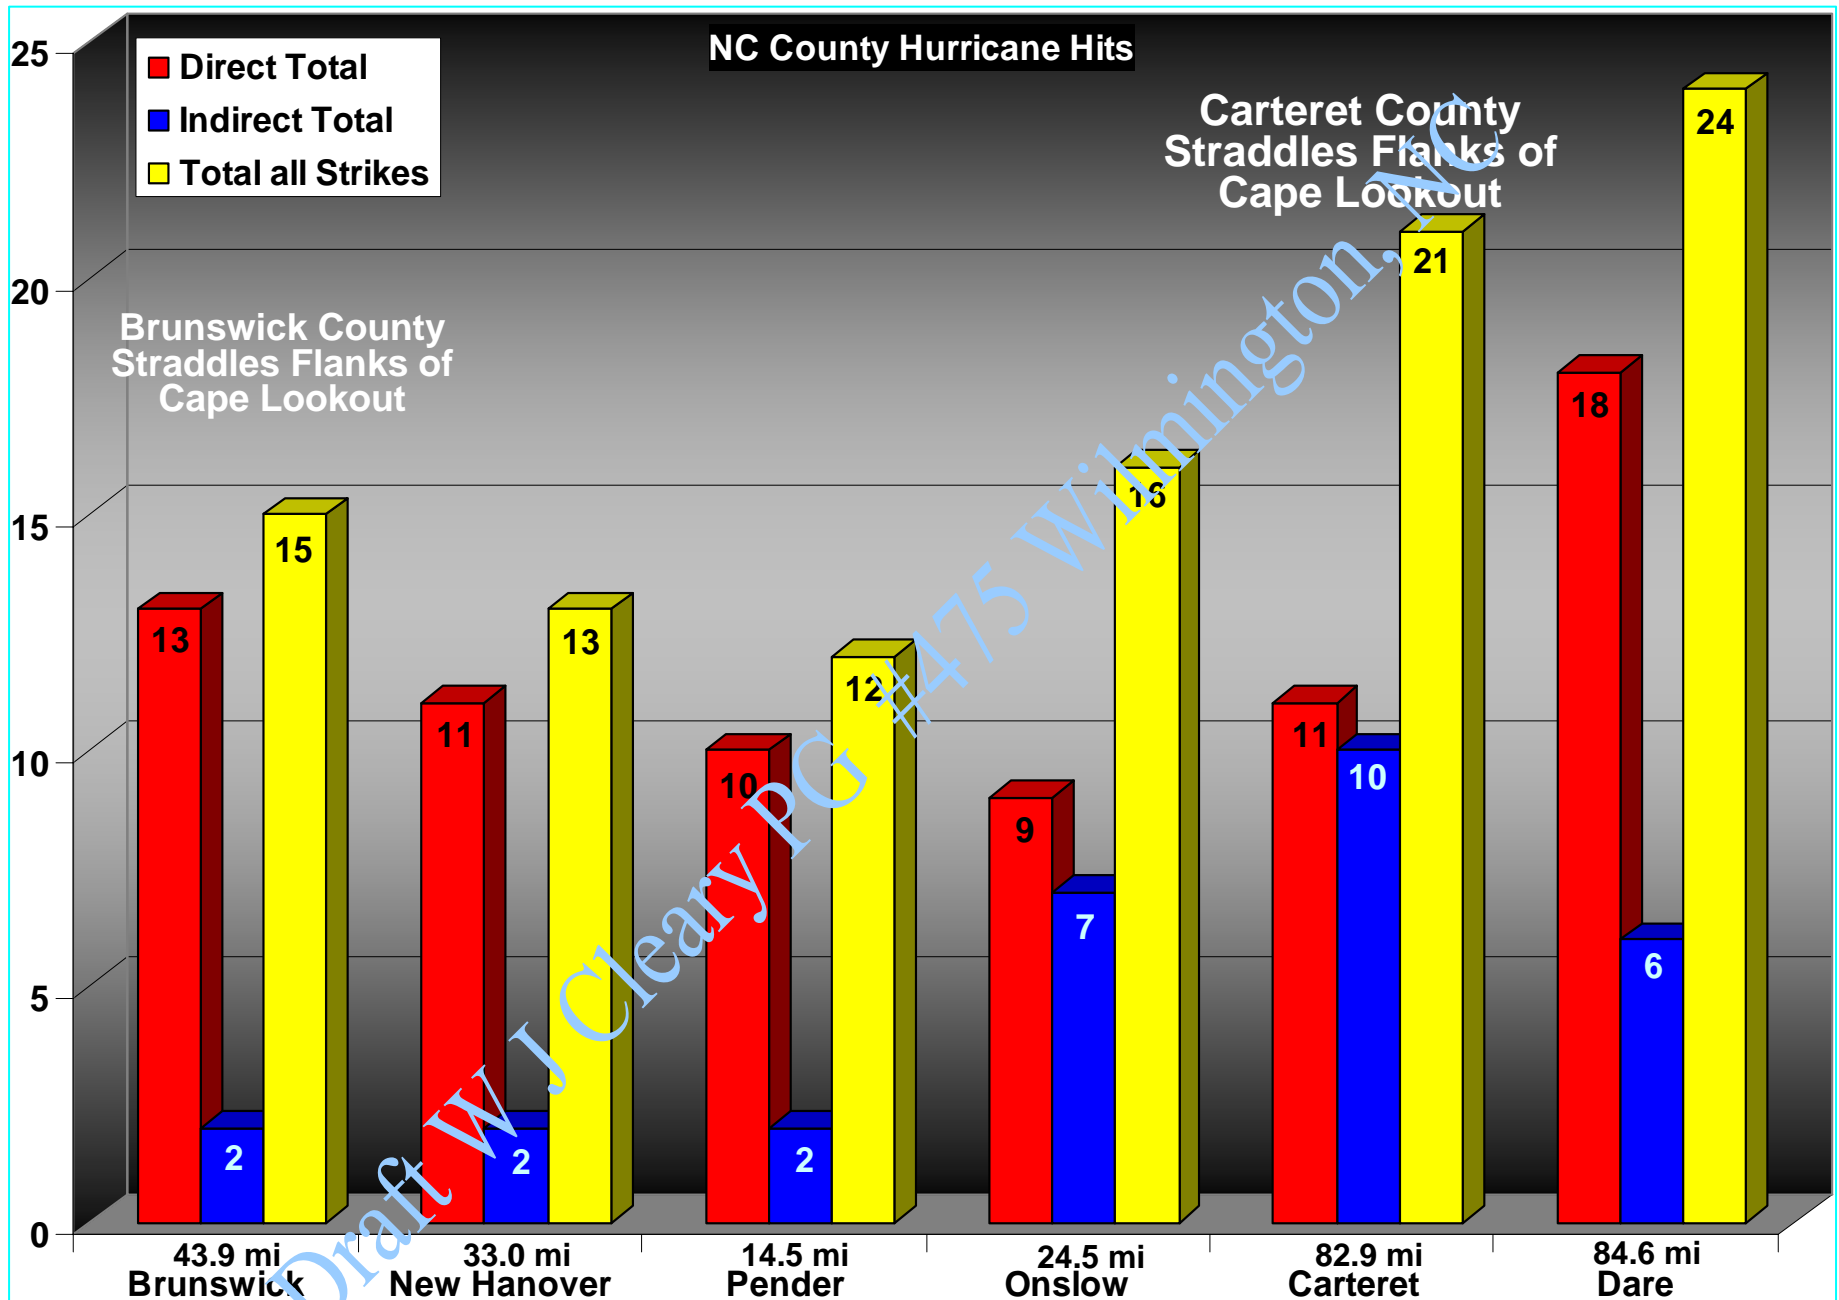
Figure 15. Bar graphs depicting select North Carolina Counties Hurricane Strikes Direct, Indirect and Total for Hurricanes H1-H4 (1900-2005). Data derived from NOAA Technical Memorandum NWS NHC -46 and unpublished NOAA hurricane strike data compiled 2/4/2010. Courtesy D. Marcy, NOAA Office for Coastal Management. See Table 1 for Brunswick and Carteret County miles of shoreline within Onslow Bay (Cape Lookout to Cape Fear).

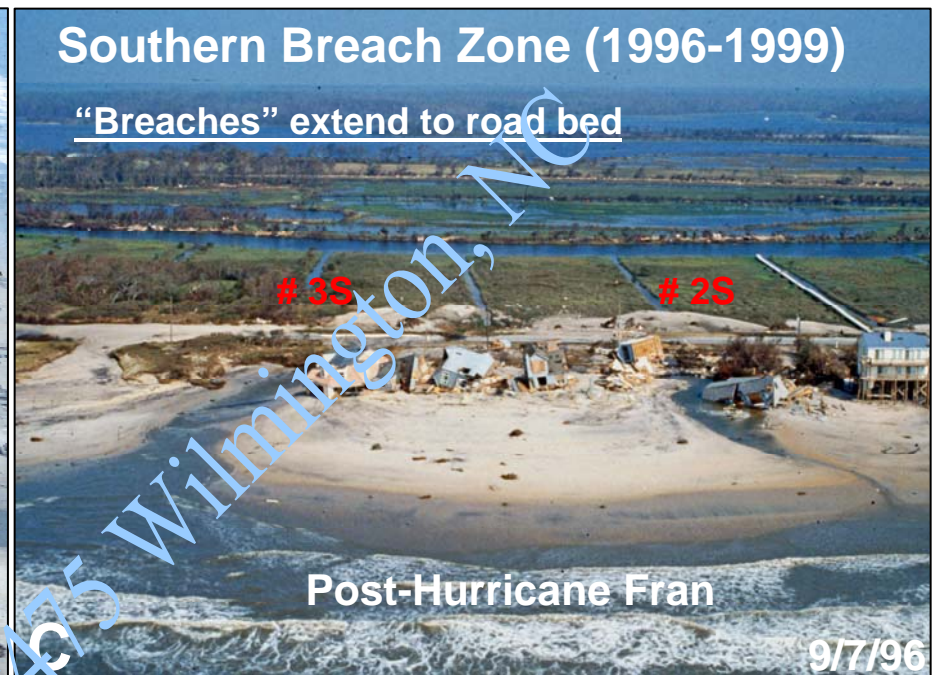
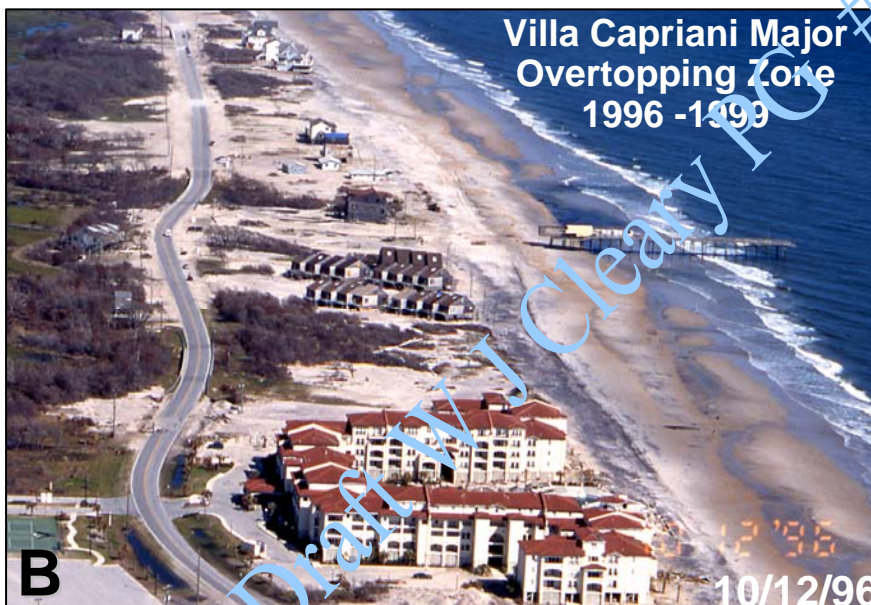
Figure 16 Oblique aerials views of Hurricane Fran-related erosion along NTB. A. North view of massive beach & dune erosion, washover fans and scour channels. B. Northerly view of Vila Capriani, washover fans and beach & dune erosion C. Landward view of southern breach zone with two scour channels. D. Northward view of southernmost NTB breach zone with island-wide washover fans, beach & dune erosion and shallow scour channel. See Figure 17 for comparison.

Figure 16 depicts oblique aerial views of post-Hurricane Fran (September 1996) conditions along four North Topsail Beach shoreline reaches, while Figure 17 depicts March 2012 views of the same four areas. Figure 17 also shows the shoreline erosion rates for the period between 1/1/1949 or 1/1/1952 and 7/11/2009 (red-colored numerals) in each of the photos (Fig. 17A-D). Only one shoreline reach has short-term erosion rates greater than 1.5 ft/yr and that is the northern breach zone (Fig. 17 A), an area that was the focus of media attention in the aftermath of the 1990s storms. The remaining three shoreline sectors (Fig. 17 B-D) are all characterized by very low erosion rates that range from (0.60 to 1.1 ft/yr).

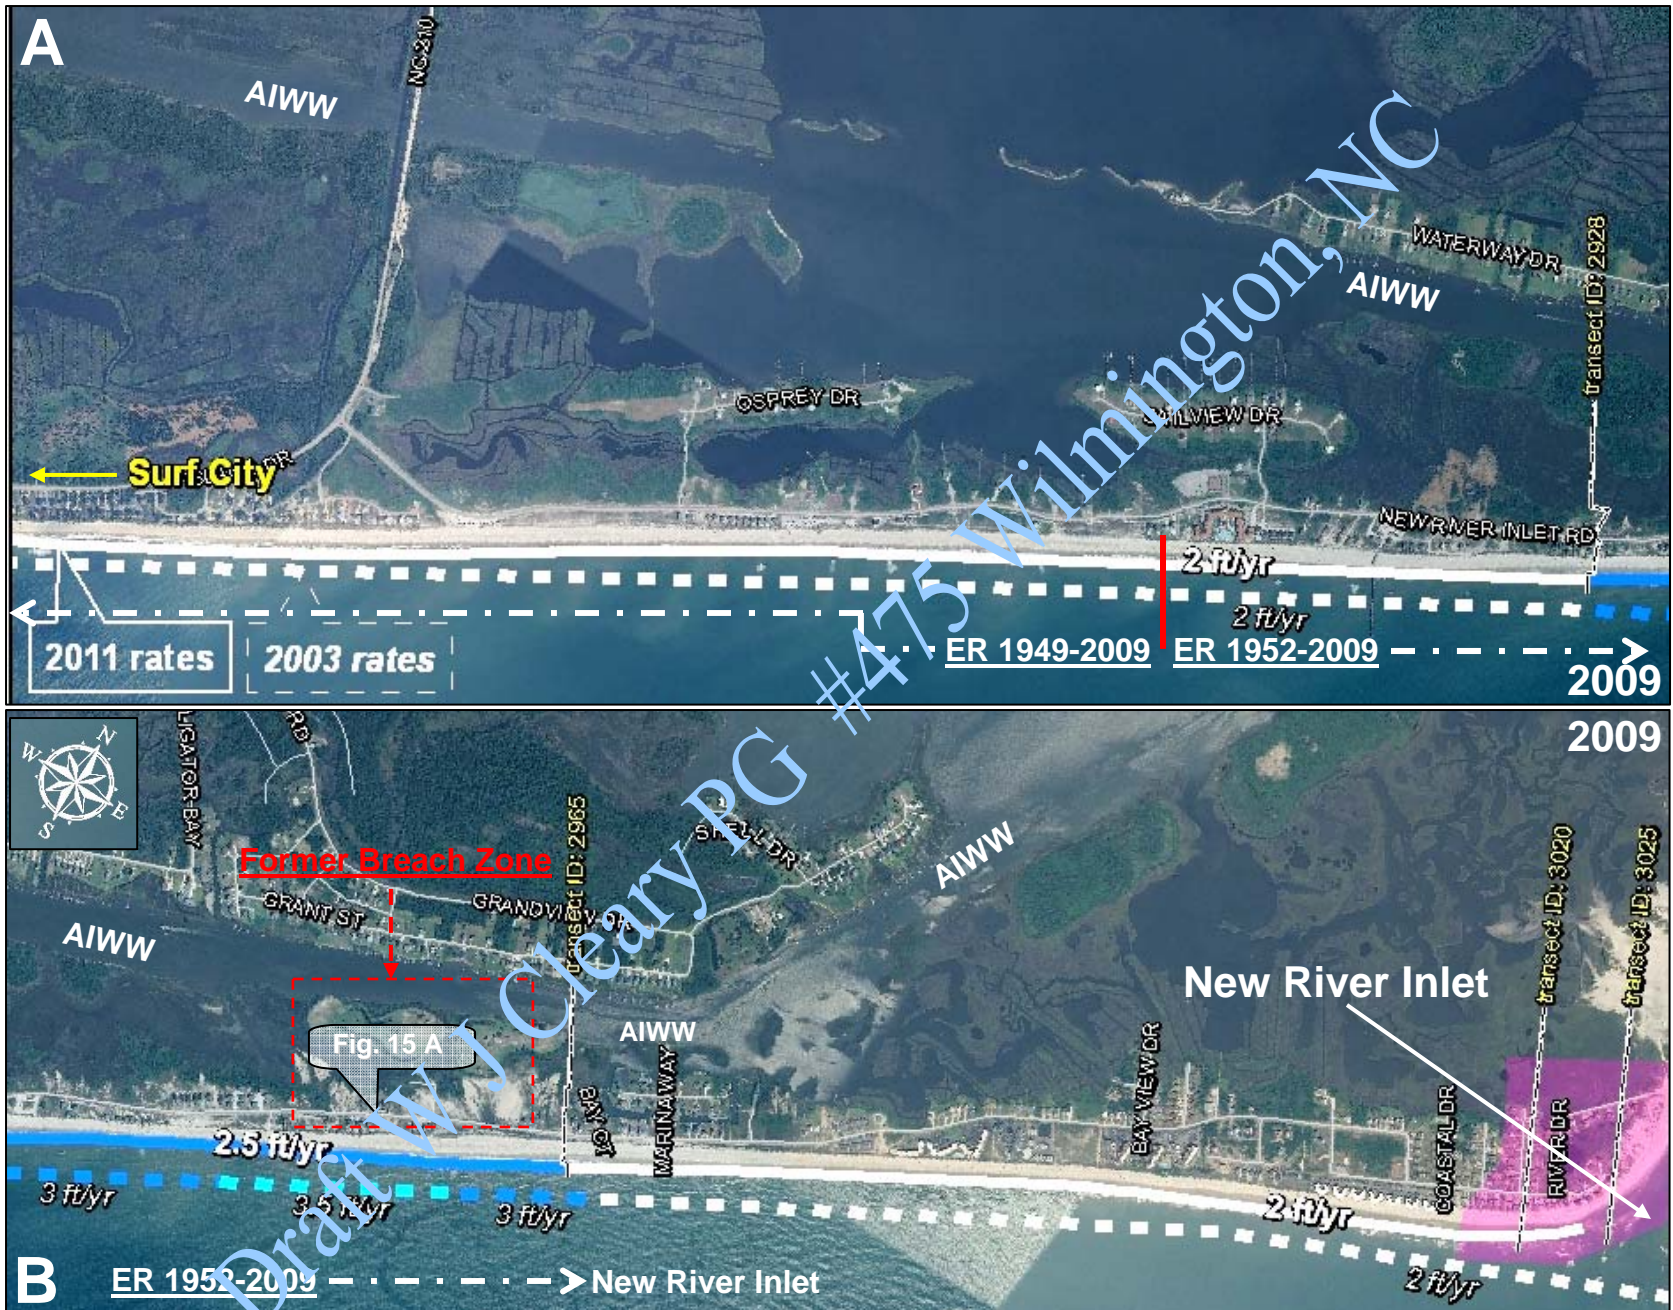
Figure 18. Photographs (2009) depicting erosion rates along the northern portion of North Topsail Beach. Modified after NC DCM 2011 ER update. Bold red colored line separates the early start years (baseline years).

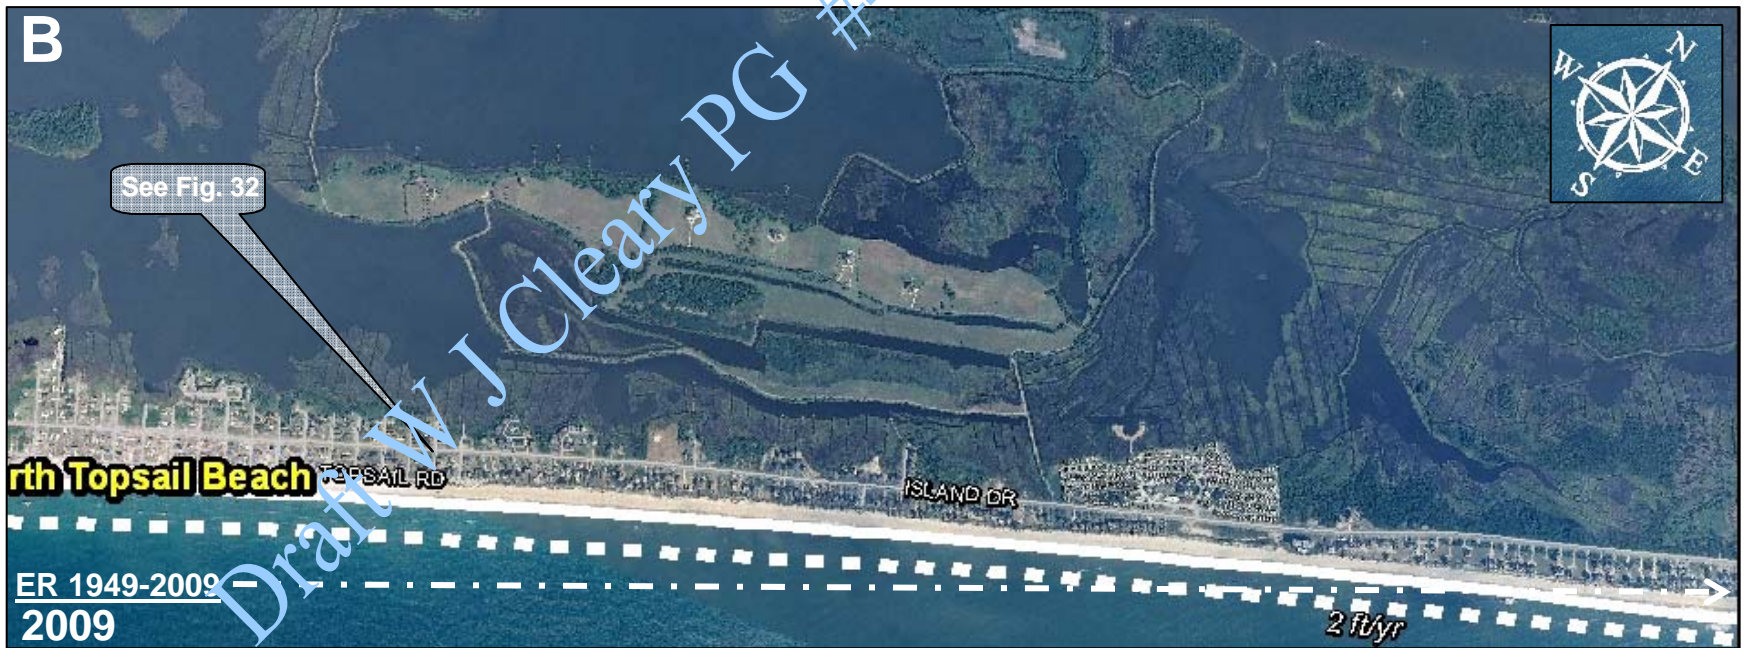
Figure 19. Photographs (2009) depicting erosion rates along the southern portion of North Topsail Beach. Modified after NC DCM 2011 update. Bold red colored line separates the early start years (baseline years).

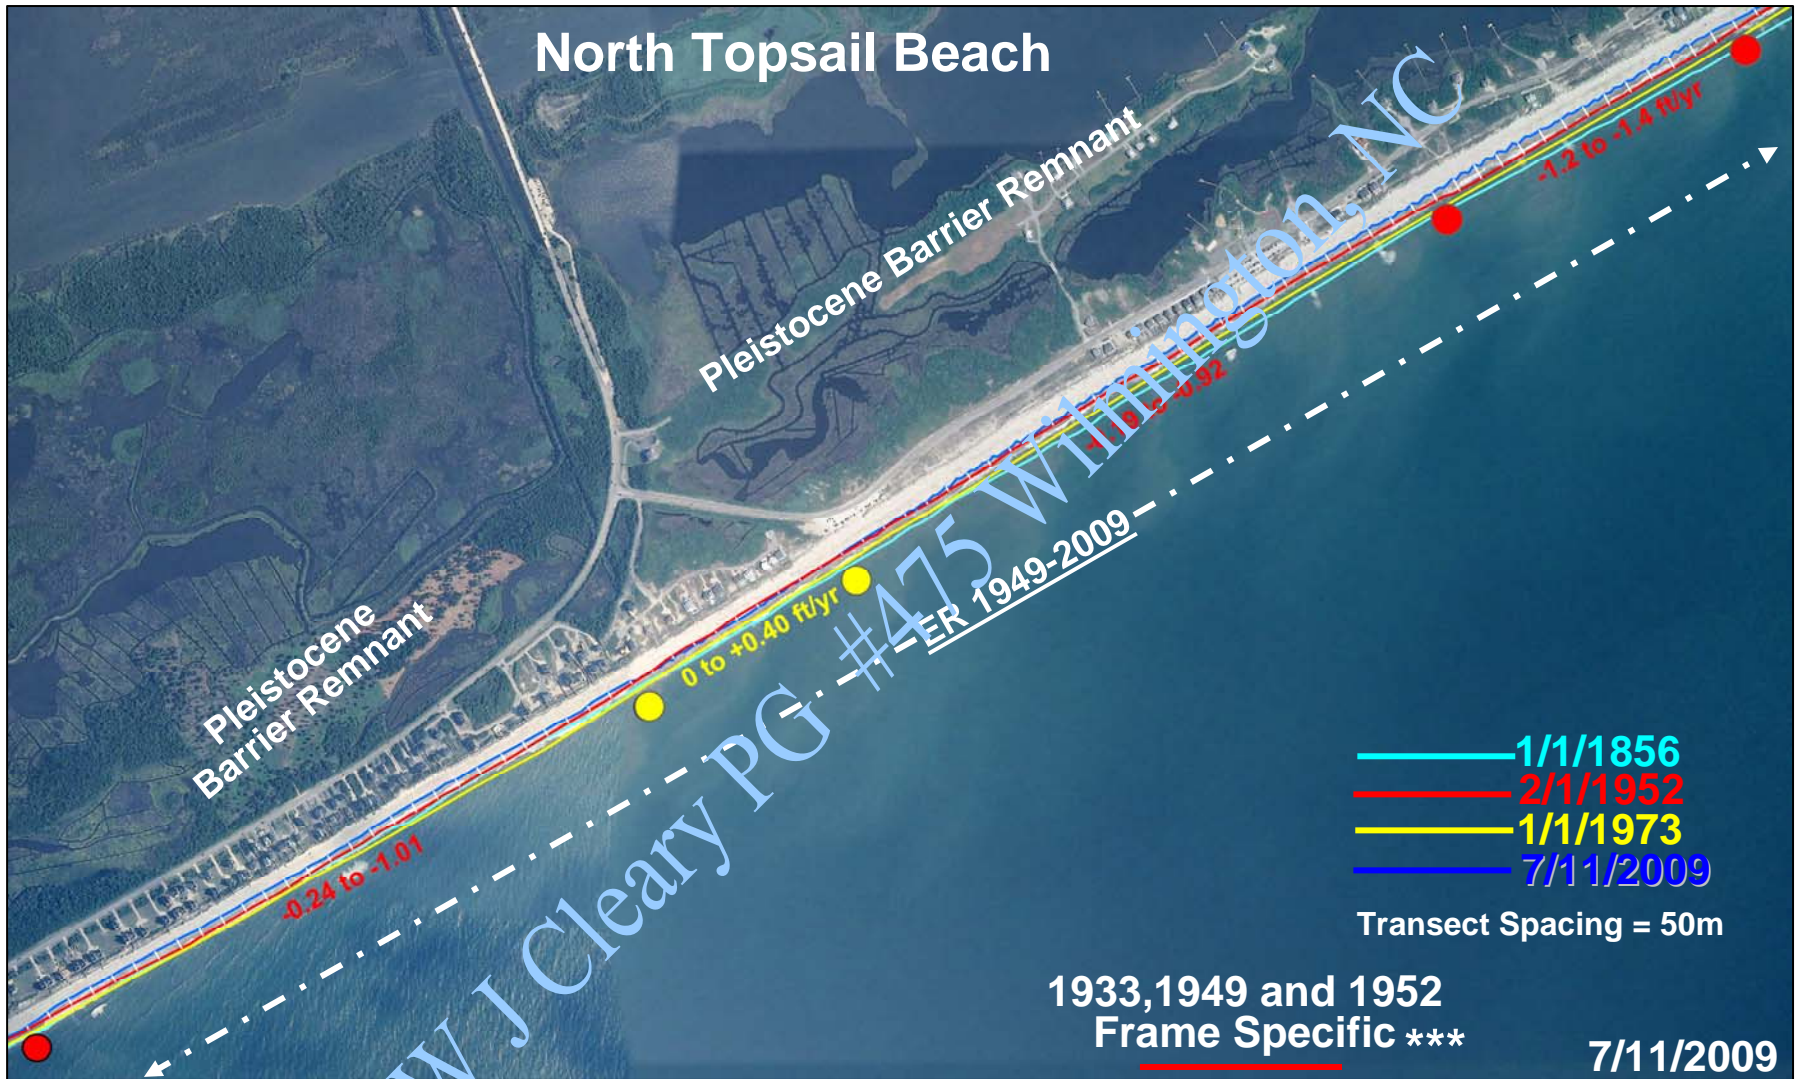
Figure 24. Map depicting 7/11/2009 photograph of the segment located immediately southwest of Figure 23 with NC DCM transects used for measuring erosion rates (2011 updated). Shoreline change rates reflect changes between 1949-2009. Transect spacing = 50m. Data derived from NC DCM's Oceanfront Setback Factor Portal and available GIS files from 2013 (transects 50m shapefile, 2009 shr1 shapefile and Early shr1 shapefile (composite shr1 file for 1933, 1949 and 1952). Additional information was provided by Ken Richardson (NC DCM). <http://portal.ncdenr.org/web/cm/oceanfront-construction-setback>.

Figures 21-27 are maps depicting the shoreline change rates for the period between the baseline year that varied with location (1933, 1949 or 1952) and 2009. The baseline year (earliest shoreline) is indicated on each map depicted (Figs. 21-17). The values depicted on each of the maps on the above mentioned figures, were derived from NC DCM's Oceanfront Interactive Map Viewer that illustrates historic oceanfront data and from downloadable GIS files (Transects 50-meter (*includes raw, smoothed, & blocked erosion rate data*)). The above maps (Figs. 21-27) clearly show that the shoreline erosion rates along the great majority of North Topsail Beach are low, and along several short non inlet-influenced shoreline sections minor accretion has occurred. These maps clearly do not support the assertion of Pilkey and Neal (2009) that high erosion rates are the norm for North Topsail Beach.

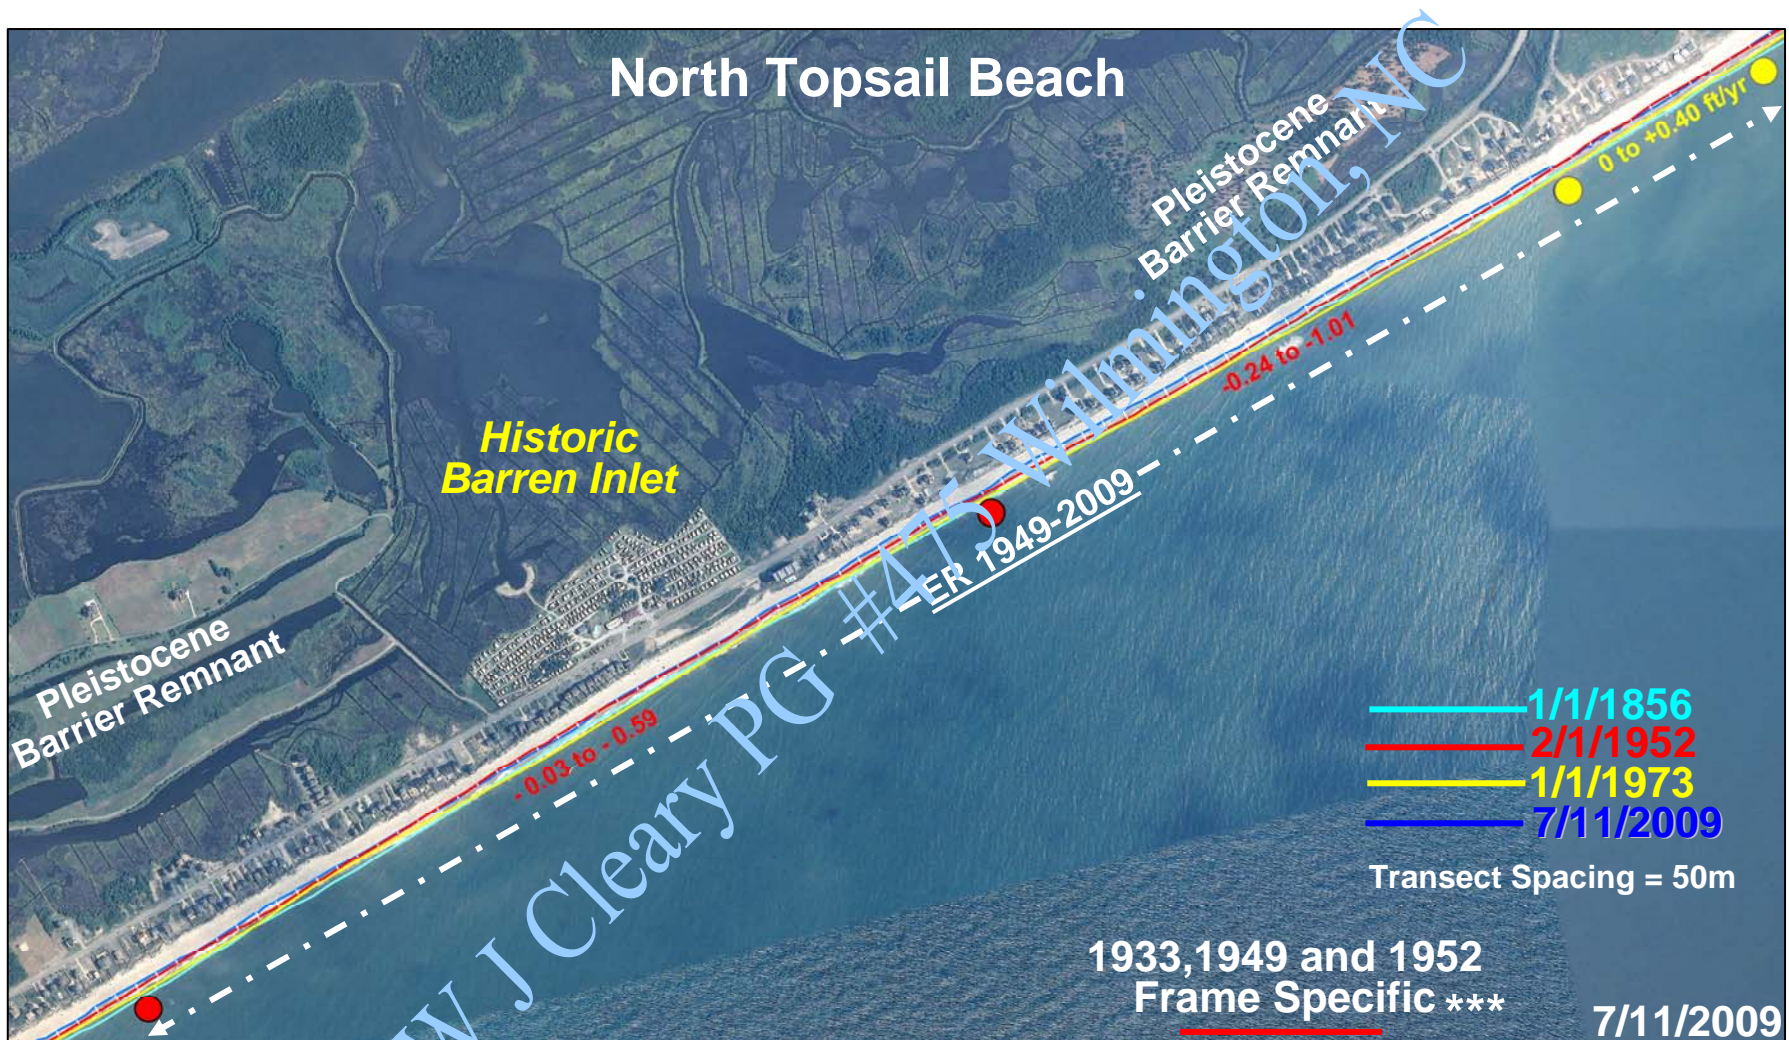
Figure 25. Map depicting 7/11/2009 photograph of the segment located immediately southwest of Figure 24 with NC DCM transects used for measuring erosion rates (2011 updated). Shoreline change rates reflect changes between 1949-2009. Transect spacing = 50m. Data derived from NC DCM's Oceanfront Setback Factor Portal and available GIS files from 2013 (transects 50m shapefile, 2009 shrll shapefile and Early shrll shapefile (composite shrll file for 1933, 1949 and 1952). Additional information was provided by Ken Richardson (NC DCM). <http://portal.ncdenr.org/web/cm/oceanfront-construction-setback>.

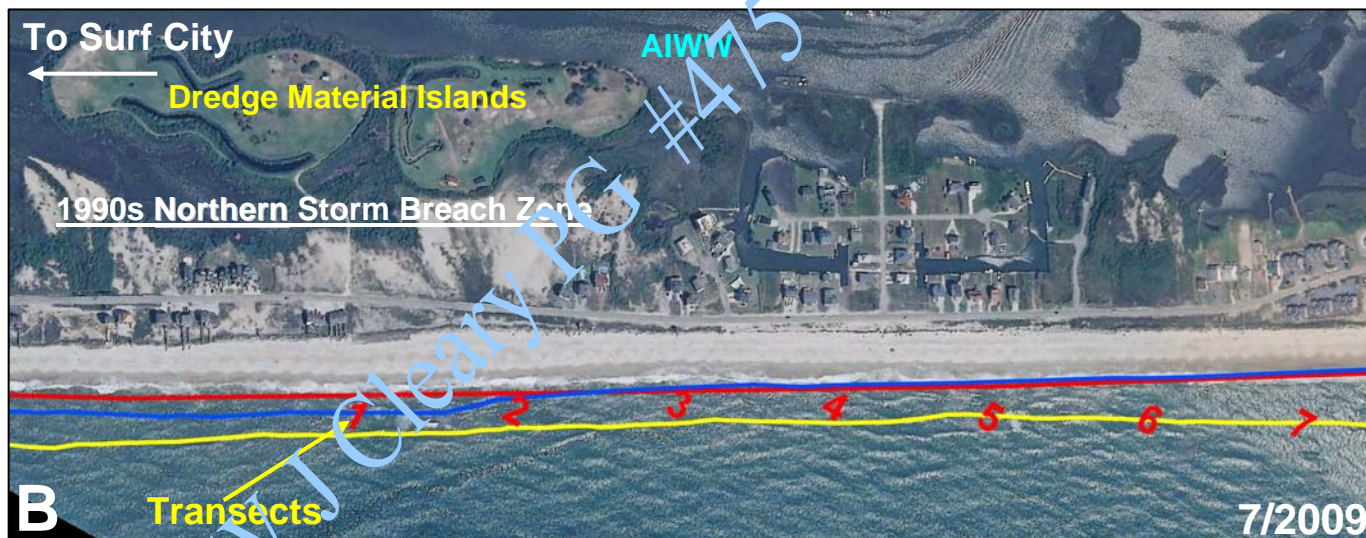
Figure 28. Maps of the northern portion of the North Topsail Beach oceanfront shoreline (2209) and positions of historic shorelines (1857, 1933 and 1952). Maps (A and B) depict transect locations (1-17) that were used to determine shoreline changes for three periods between 1857 and 2009. Spacing between adjacent transects = 655 ft. Small colored circles refer to nodal points associated with the ebb-tidal delta's limit of influence (colored polygons).

Figure 28 is a map that depicts a July 2009 photograph with the historic shoreline positions for 1856, 1934 and 1952. The above maps depicted by Figure 28 were used to determine the shoreline changes along a shoreline segment that transitioned from a non-inlet influenced reach to a one where the New River Inlet ebb-tidal delta changes controlled the shoreline change during the past 60 yrs. The red-colored numbers (1-17) represent transect locations that were used for the measurement of shoreline change for three periods (1856 - 1934, 1934 - 1952 and 1952 - 2009). The shoreline reach depicted in Figure 28 is ~2.4 miles in length and is comprised of a ~1.5 mile-long shoreline reach influenced by changes associated with the New River Inlet System.

The highest erosion rates along the shoreline imaged on Figure 28 occurs along the shoreline segment located between T1 and T3. This area was the site of massive cross-island washover features that formed during the hurricanes of the mid-late 1990s. The erosion rates for the period 1952-2009 in this area range from 2.0 to 3.2 ft/yr. By comparison the shoreline segment that extends from T3 to the T10 (inlet-influenced) is characterized by erosion rates that range from -0.6 ft/yr to -2.0 ft/yr. The average erosion rate along the aforementioned shoreline reach (T3-T10) is -1.4 ft/yr. These data as well as those previously described, clearly refute the assertions and opinions of Pilkey and Neal (2009).

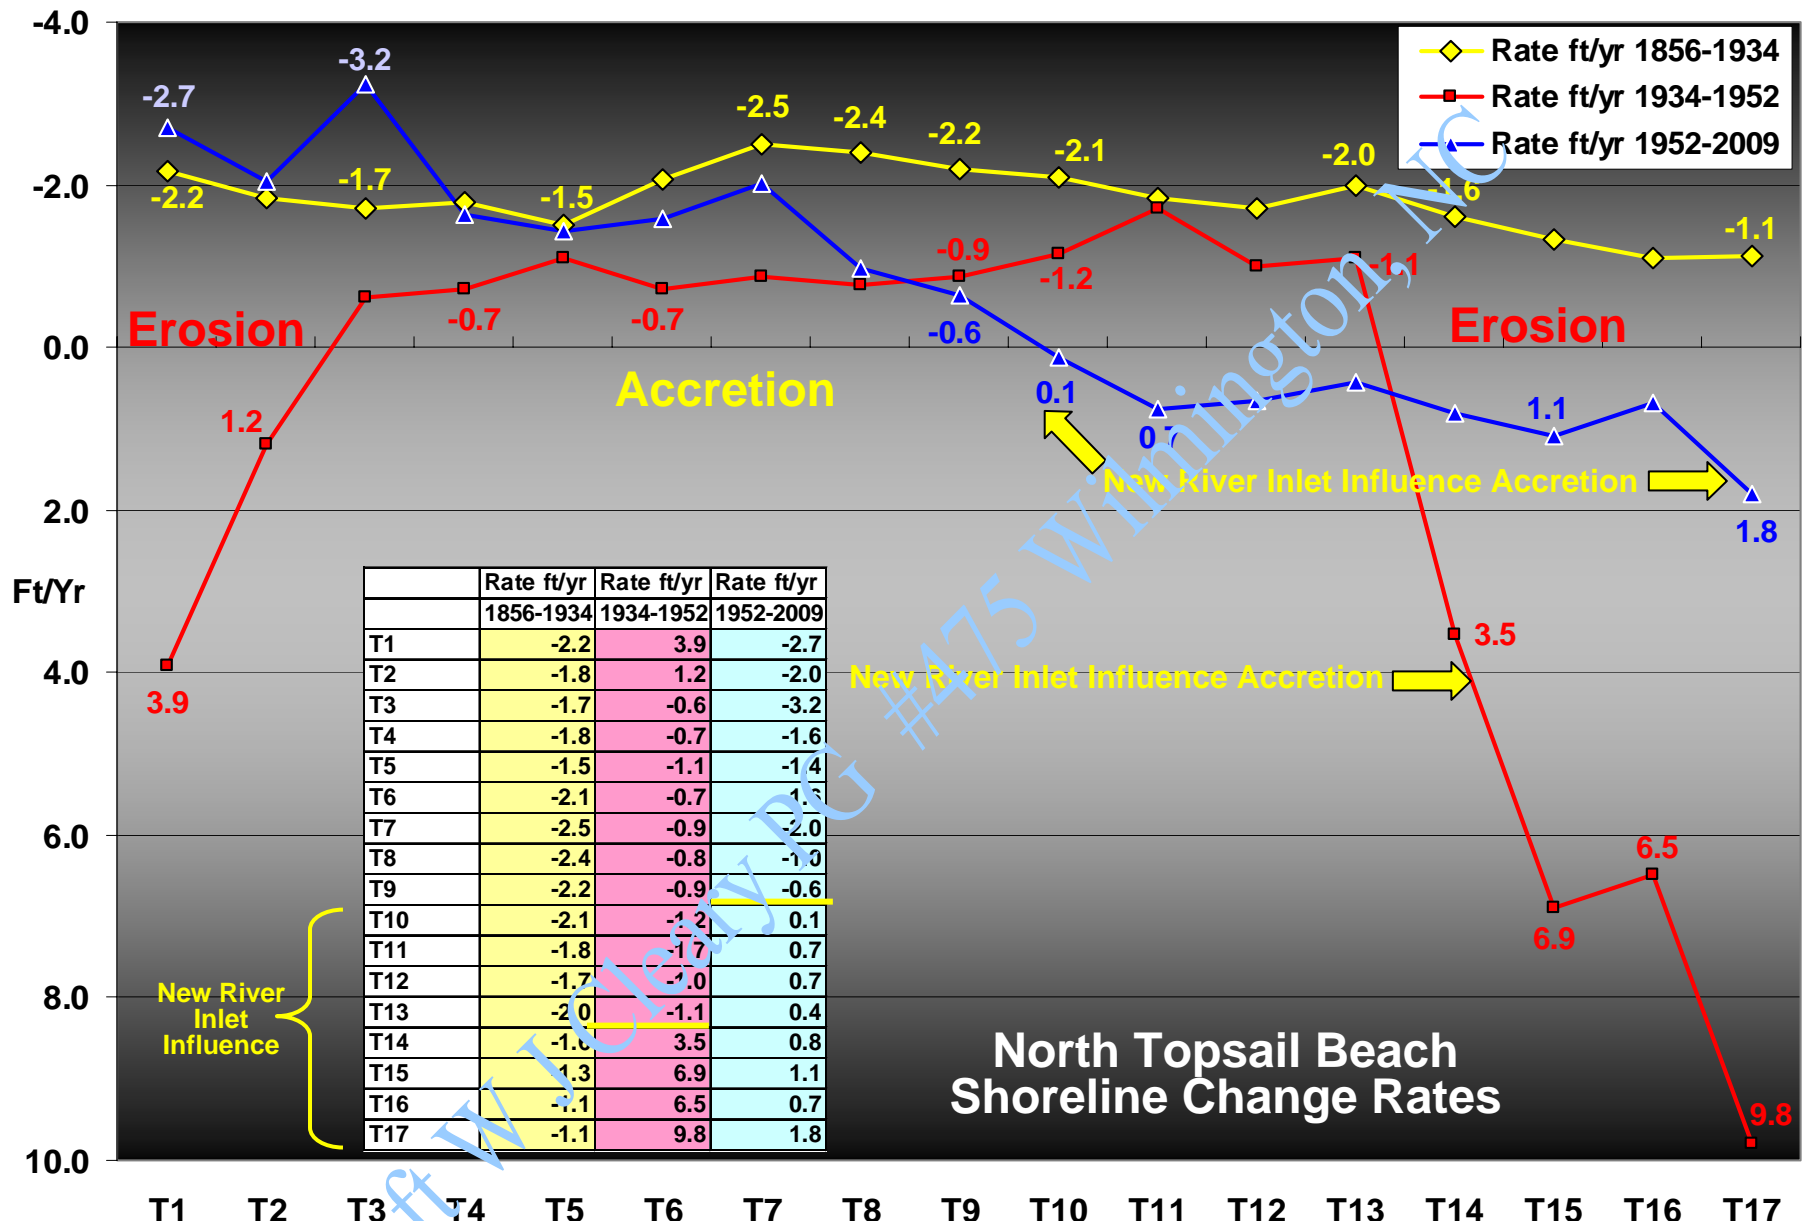
Figure 30. Line graph depicting the North Topsail Beach oceanfront shoreline change rates (ft/yr) for the periods between 1857 and 1934, 1934 to 1952 and 1952 to 2009. Between 1934 and 2009 the erosion rates for nearly all transects were less than 2.0 ft/yr. Along the inlet-influenced shoreline reach accretion rates for the period 1934 to 1952 ranged from 3.5 -9.8 ft/yr reflecting the initial adjustment of the shoreline near the newly relocated inlet (ca 1940). Rates of progradation are significantly lower along the inlet influenced for the period between 1952 and 2009 due the deflection and realignment of the ebb channel that began in the early 1990s

Figure 30 illustrates the average annual change rates for the above mentioned time-intervals for the shoreline segments depicted on the maps comprising Figure 28. The majority of the shoreline segment (T9-T17) imaged on Figure 28 A has historically been strongly influenced by the location of New River Inlet's ebb-tidal and its shape changes since the 1950s. The colored dots (Fig. 28) delineate the ebb-tidal delta's southwestern limit and the lateral extent of its influence along North Topsail Beach. Inspection of Figure 28 A shows that between 1954 and 1987 (colored dots) the ebb-tidal delta's influence steadily shifted to the southwest. During this period of time the oceanfront shoreline (~T9-17) prograded (accreted). A reversal in the shift direction occurred in the early 1990s when the outer portion of the ebb channel began deflecting to the northeast and as a consequence the extent of the ebb-tidal delta shifted toward the northeast and the mouth of the inlet. The locations of the 1998 and 2003 colored dots reflect the above

mentioned northeasterly shift. As a result of the northeasterly shift, the once-accreting shoreline after a short-time lag began to erode.

An inspection of Figure 29 shows that during the period 1934 to 1952, the shoreline located between T14 and T17 accreted as much as 178 ft at rates as high as 9.8 ft/yr (Fig. 30). The accretion occurred concurrent with the erosion of the shoreline located between T3 and T13. The above shoreline change trends reflected the enlargement of the ebb-tidal delta and its gradual southwesterly shift along the downdrift shoreline, as New River Inlet (ebb channel) migrated in a southerly direction. The period between 1952 and 2009, brackets the interval when the ebb-tidal continued to enlarge (1952) and when it ultimately reach its most southwesterly extent (1987), and the interval (1990-2009) when the ebb-tidal gradual shifted to the northeast. An examination of Figure 29 shows that during the above period, the shoreline between T10 and T17, accreted by as much as 104 ft at rates of 1.8 ft/yr. It is beyond the scope of this brief report to expand the narrative dealing with the influence of the inlet, suffice to say it plays an important role in the shoreline change patterns along a minimum of 1.5 miles of the North Topsail Beach oceanfront.

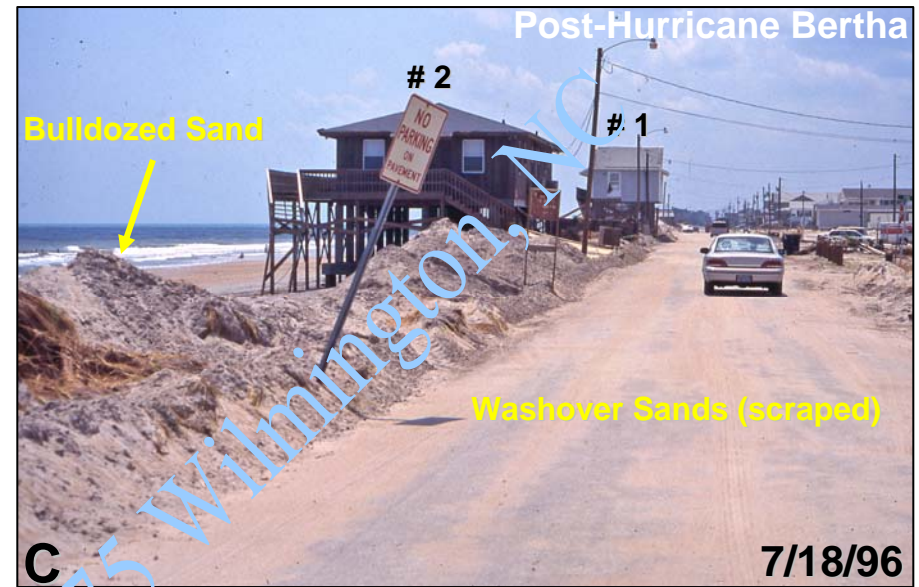
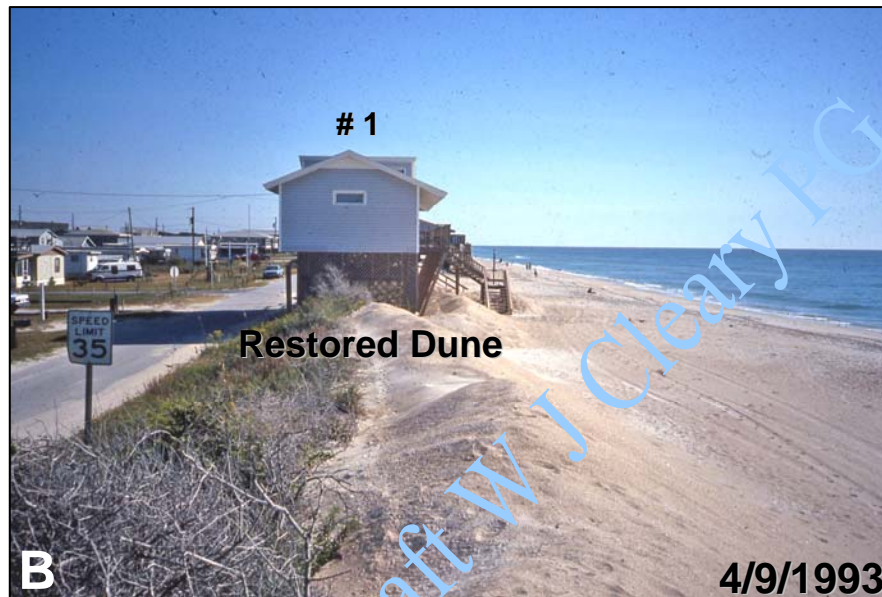
Figure 32. Shoreline changes along southern portion of North Topsail Beach between April 1993 and July 1996. A. Map (7/2009) depicting shoreline conditions along southern oceanfront of North Topsail Beach with selected historic shoreline positions and houses (# 1 and #2 Reference locations). Insert is a table of shoreline change rates for various periods between 1856 and 2009. The NTB shoreline is characterized by low average change rates. B. North view (4/9/1993) of Home (# 1) that rests atop the restored dune ridge. C. Post-Hurricane Bertha view (7/18/96) of overtopped restored dune line and road. D. Post-Hurricane Fran view (9/7/96) of the refurbished dune line and washover-related sediments strewn across street.
