Incident Waves, Historic Hurricane History and North Topsail Beach Shoreline Erosion Rates

William J. Cleary

10 January 2015

Characteristics of Incident Waves, Historic Hurricane History and North Topsail Beach Oceanfront Shoreline Erosion Rates

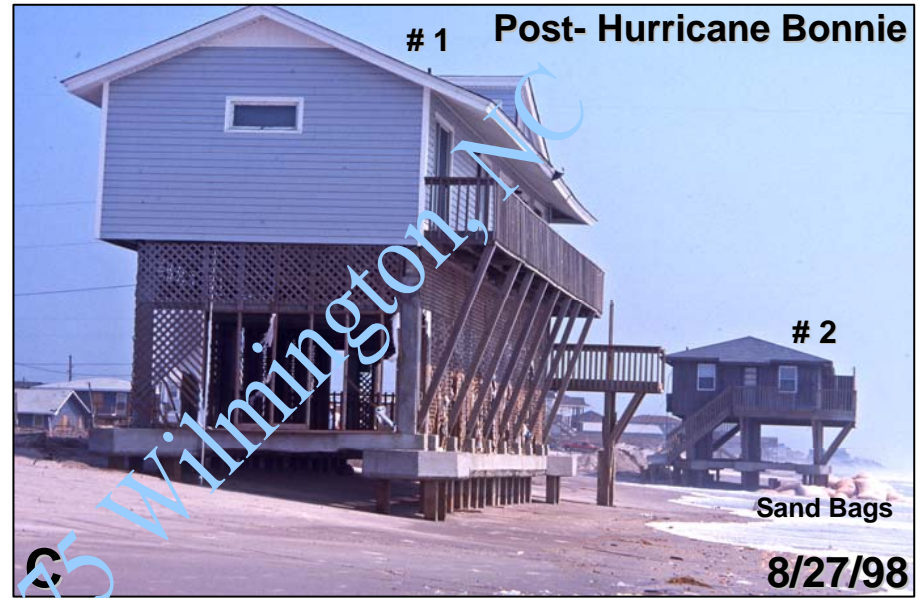
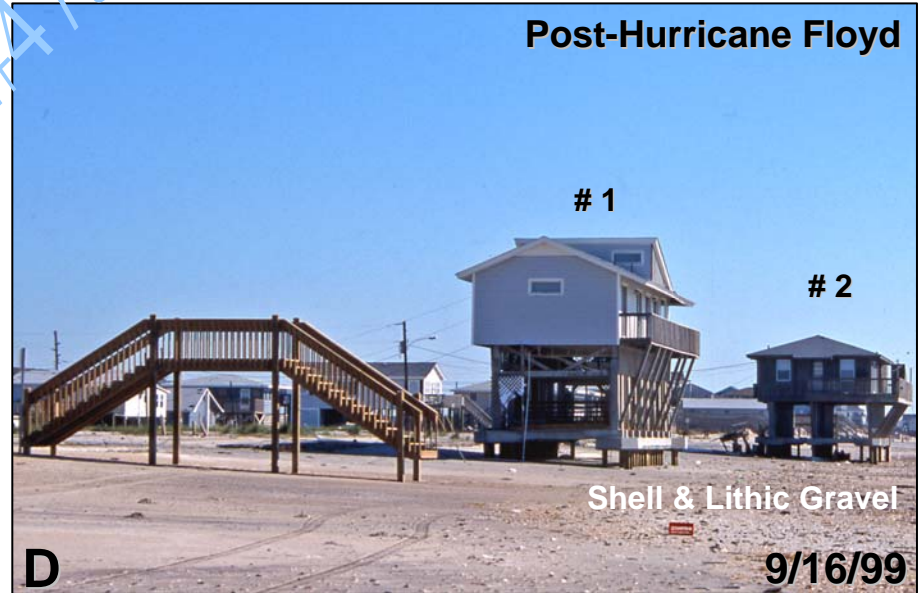
Figure 33. Shoreline changes along southern portion of North Topsail Beach between October 1996 and September 1999. A. Post-Hurricane Fran northerly view (10/12/96) of houses with foundation slabs and pilings exposed. Note lack of dunes. B. Landward aerial view (8/28/98) of Post-Hurricane Bonnie's impact. Note washover-related sediments extend to highway and no dunes are present. Foundations of houses are exposed. C. Northerly view (8/27/98) of homes with foundations exposed. Post-storm upper fore-shore profile is steeper than the post-storm profile following Hurricane Fran (A). D. Landward ground level view (9/16/99) of homes following Hurricane Floyd. Note lack of a dune line.

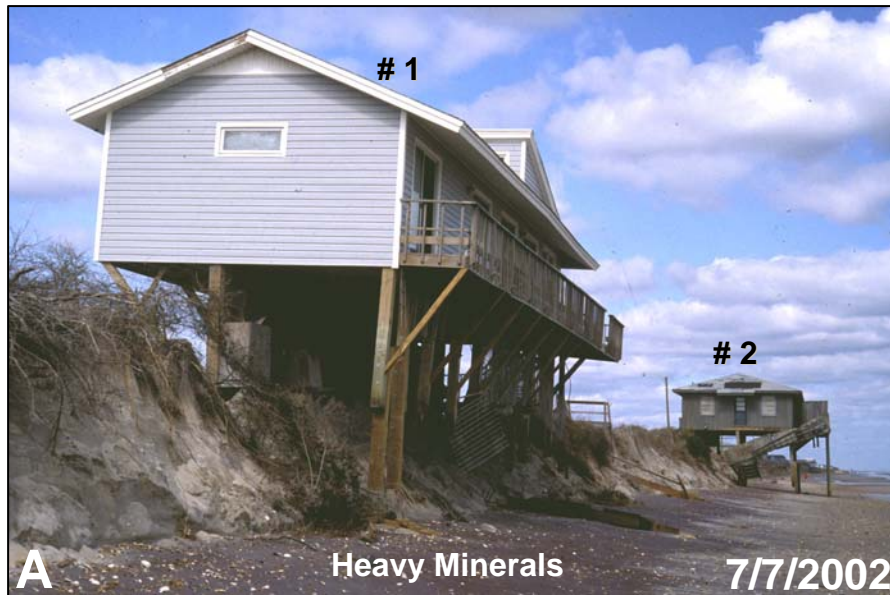
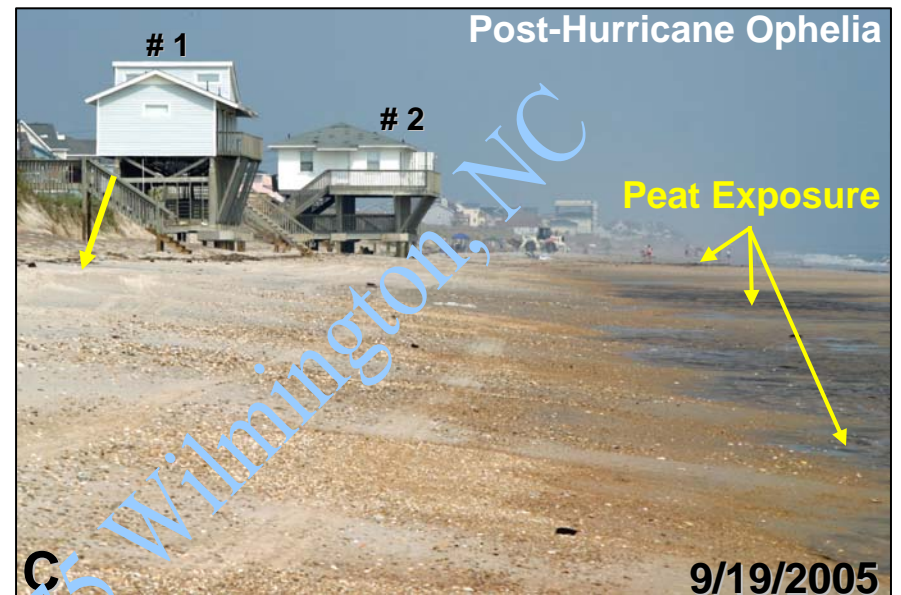
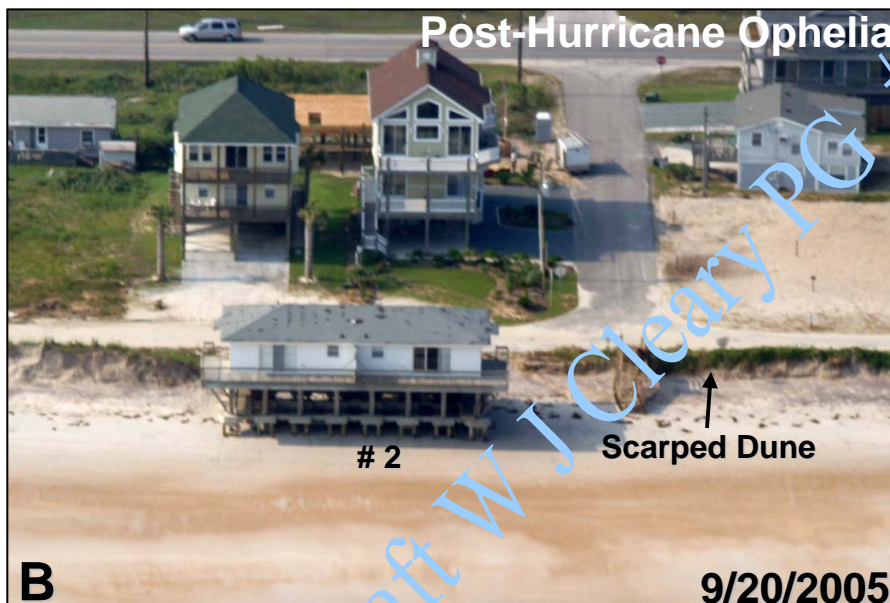
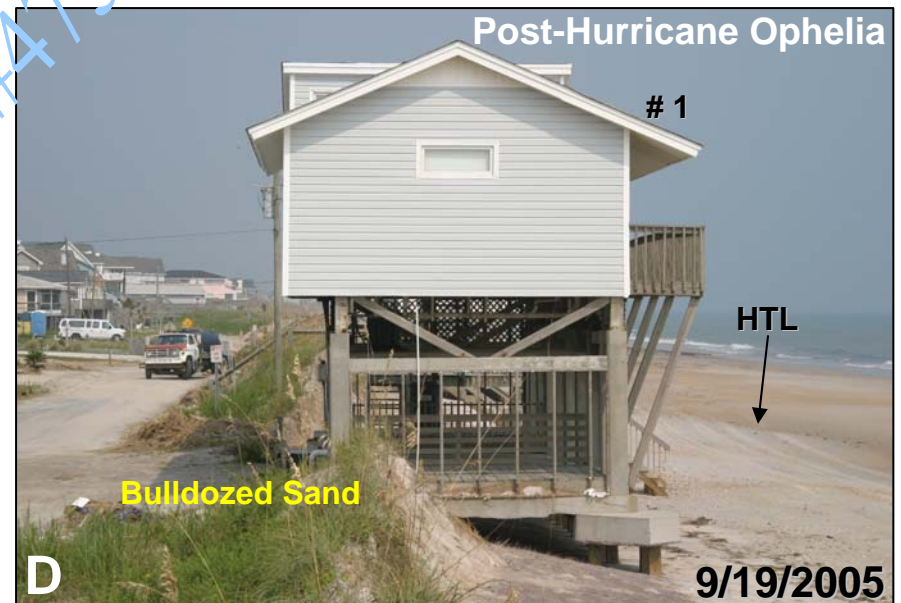
Figure 34. Shoreline changes along southern portion of North Topsail Beach between July 2002 and September 2005. A. Northerly view (7/7/02) of homes perched along artificial dune line. Note pilings are exposed near HT swash line. B. Aerial view (9/20/05) depicting the minimal impact of Hurricane Ophelia. Note scarped dune line and position HT line. C. Northerly view (9/19/05) of homes with exposed foundation slabs. Note gravel strewn foreshore. Coarse shell and lithic fragments were derived from residual sediment accumulations that mantled hardbottoms. Extensive high-marsh peat exposures front much of this area. D. Northerly view of home # 1 along restored dune line. Despite numerous tropical storms, hurricanes and extra-tropical storms, some of which produced surges that inundated the island, the HTL position has changed very little since 1952. Erosion rates in this vicinity range from 0.6 to 0.7 ft/yr. See Figure 32 A.

Figure 34 A-D shows the erosion of the dune line and the flattening of the profile during Hurricanes Fran, Bonnie and Floyd. In the aftermath of each of the storms, the washover sand deposition extended to the highway. Figure 35 A-D depicts the homes straddling a refurbished dune line. Figure 35 C depicts an extensive exposure of high-marsh peat with cedar stumps and shrub roots that underlies the lower foreshore portion of the profile. This unit crops out along a lengthy portion of the southern portion of North Topsail Beach, particularly in a northeasterly direction. Figure 36 A-C depicts the homes as of 8/6/2014 near a low tide condition. The position of the HTL (wrack line) is variable as evidenced by the images. The reason the shoreline in this area has been retreating very slowly during the past century (See Fig. 32A insert) is difficult to explain considering the storm history of the island. What effect the extensive peat unit has on the low retreat rate is unknown and is beyond the scope of this report.

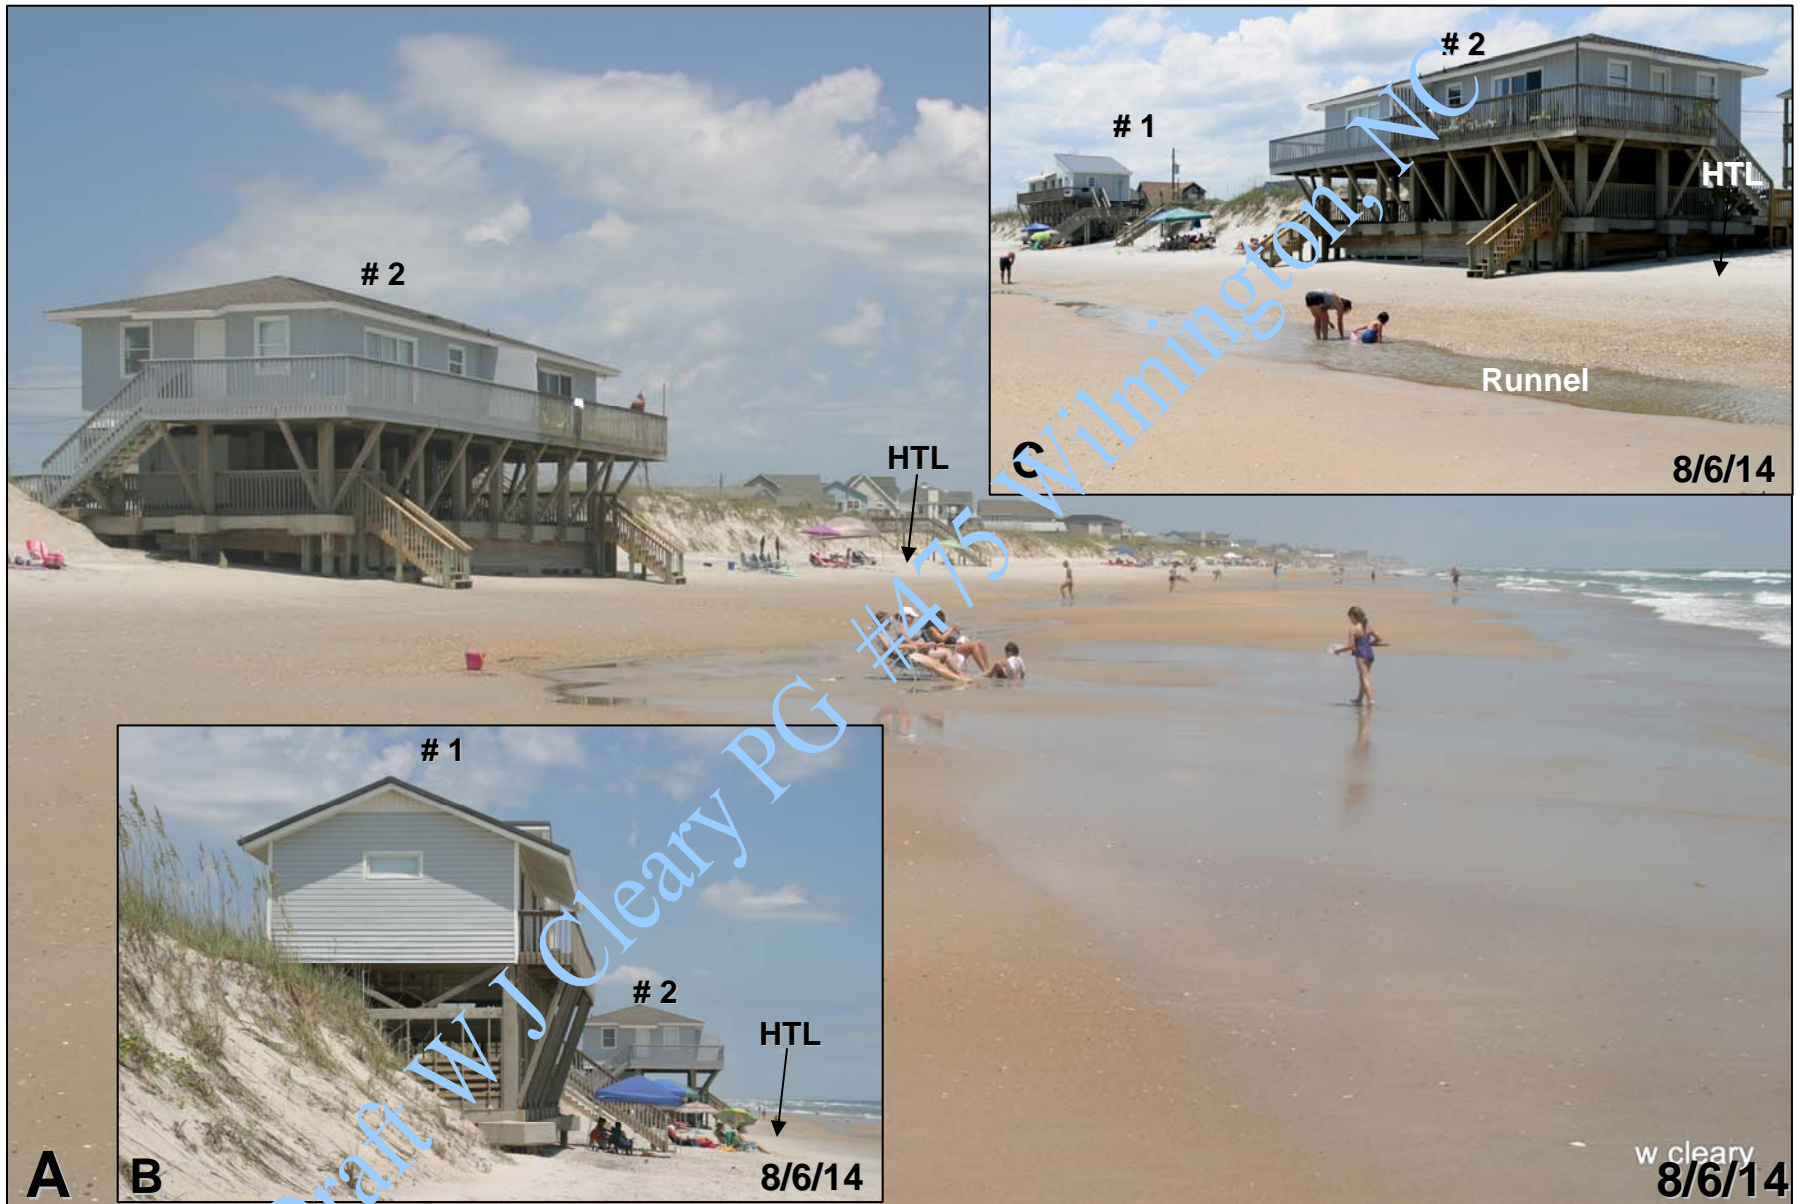
Figure 35. The NTE shoreline during a rising Spring tide on 8/6/14. A. Northerly view of home #2 perched along the dune. Note position of the HT swash line. B. Northerly view of homes #1 and #2 along dune line. High tide swash line lies near base of dune. C. Southerly view of homes # 1 and # 2. Despite numerous storms that eroded the dunes, the HTL position has changed little during the past 25 years.
